Research Report  
KTC-99-61

**EVALUATION OF THE ADAPTIR SYSTEM  
FOR WORK ZONE TRAFFIC CONTROL**

Kentucky Transportation Center  
College of Engineering  
University of Kentucky  
Lexington, Kentucky

November 1999

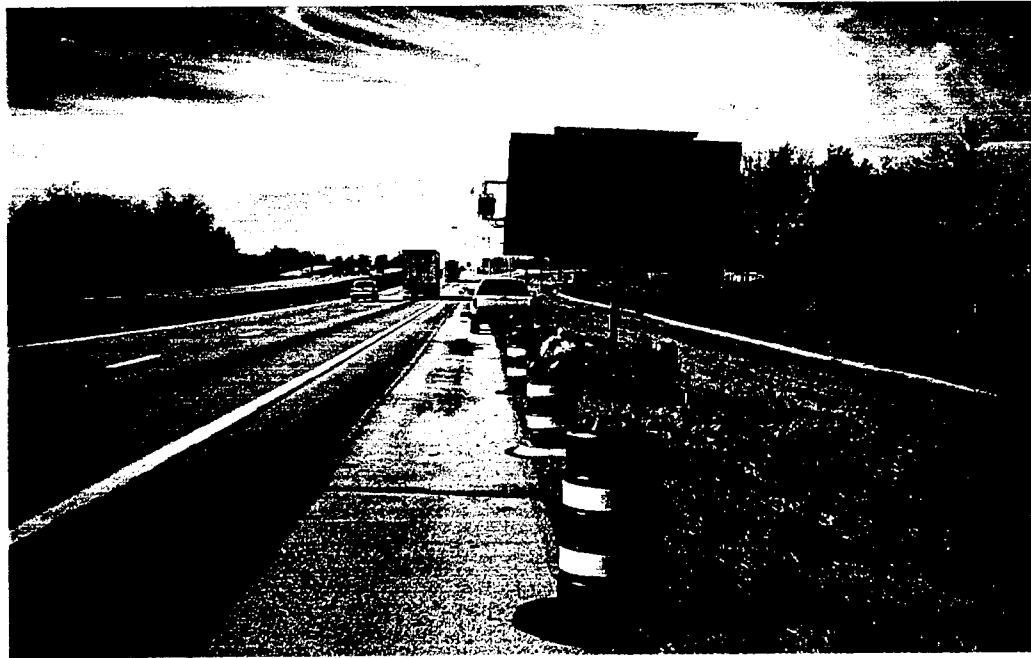
Figure 1. Variable Message Sign Equipped with Radar Unit.

The ADAPTIR system uses variable message signs (VMS) equipped with radar units (Figure 1), along with a software program to interpret the data, to display appropriate warning and advisory messages to motorists approaching a work zone when certain speed and delay thresholds are met. The messages warn drivers when average speeds are reduced ahead, when delays become excessive, and advise the motorist of long delays when use of an alternate route should be considered.

Both the ADAPTIR and contractor's systems used radar units to collect speeds at a series of four VMS leading to the work zone along with another radar unit on the arrow display at the lane closure. While the distances varied slightly, the first VMS was typically located about 4 to 5 miles from the lane closure with the lane closed about 2.5 miles. The ADAPTIR and contractor's systems were used in addition to the typical traffic control measures used for a lane closure on a multi-lane highway. Three types of messages were displayed. The messages dealt with a reduction in speed, a level of delay, and the display of an alternate route. Certain criteria were used in the development of the messages. Each warning consisted of two messages. Each message had three lines with a limit of eight characters for each line.

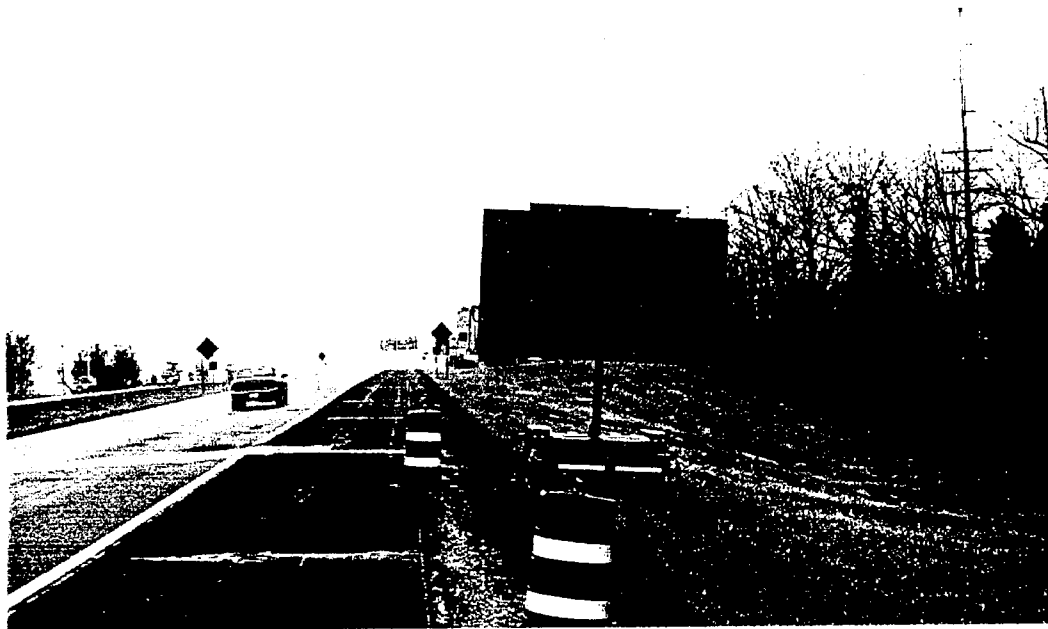
Figure 2. Message Showing Current Time.

ROADWAY		REDUCE
ADVISORY		SPEED TO
XX AM OR PM	followed by	XX MPH

Photographs showing these messages are shown in Figures 2 and 3. The message was updated every two minutes for the ADAPTIR system used in the westbound direction and every three minutes for the contractor's system in the eastbound direction. The "time stamp" gave a new time so motorists would realize the information was current. The speed was given in five mph increments with the speed rounded to the next lowest five mph interval from the average. If traffic was stopped at one location giving a zero speed, the upstream VMS gave a speed of five mph.

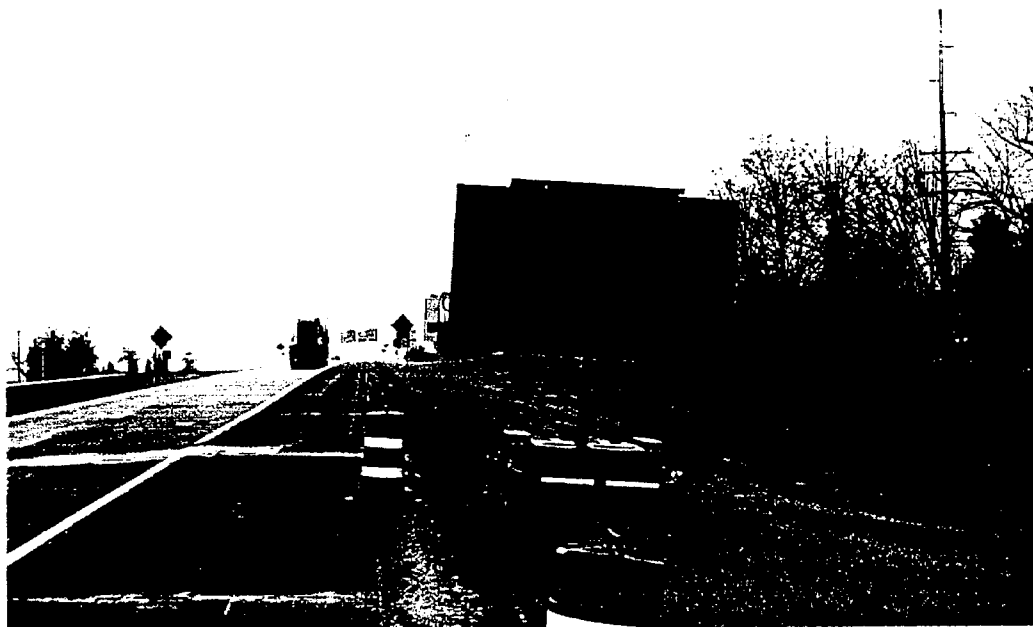
Figure 3. Speed Advisory Message.

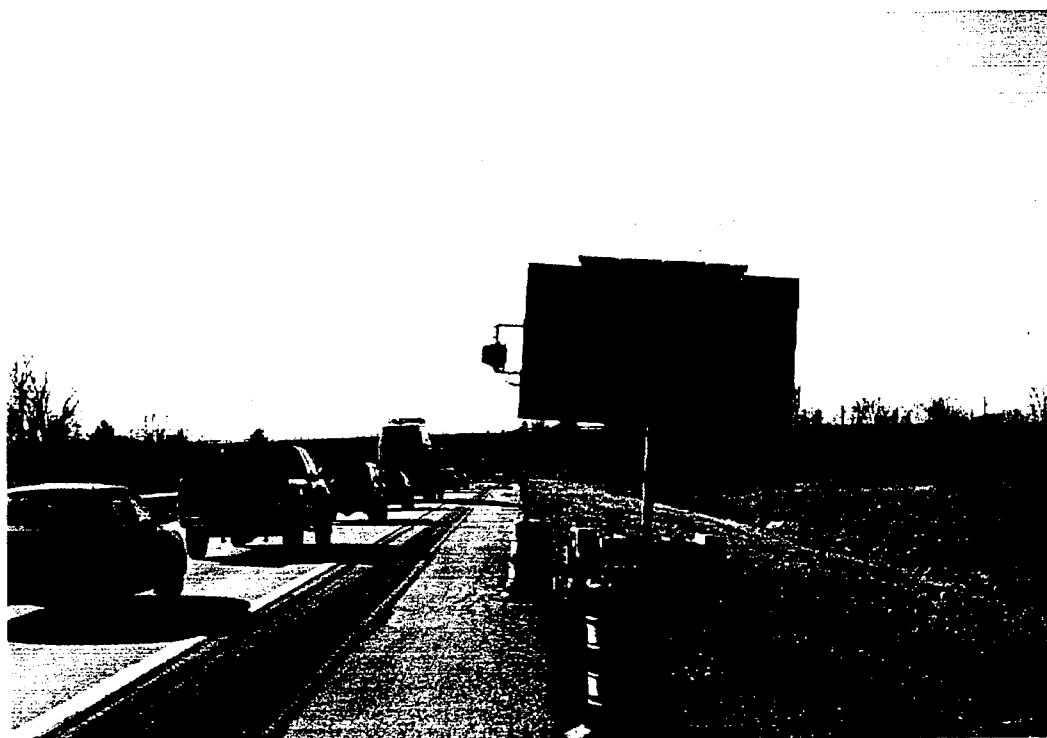
Figure 4. Delay Message.

The delay from a specific VMS to the end of the work zone was calculated by comparing the time necessary to travel from that VMS at the posted speed limits compared to the time required to travel through the work zone at the speeds measured by the radar units. The speed limits used were 65 mph in advance of the lane closure and 55 mph through the lane closure and extending approximately to the first VMS. Slightly different methods were used by the two systems to determine speeds between signs. Either the speed determined at a specific sign was used as the speed to the next downstream sign or the average speeds between two adjacent signs were used as the speed between those signs. The speed at the arrow display was used as the speed through the lane closure portion of the work zone. A minimum speed was used through the work area (after the start of the lane closure) since no radar units were placed in this area. A minimum speed of 10 mph was used by ADAPTIR. The length of the work area (lane closure) varied slightly depending on where the work was being conducted. In any case, the work zone was a few miles in length and the speed at the arrow display (with the specified minimum) was used over this length. A delay message was displayed when the delay through the work zone reached a threshold of five minutes. The delay message consisted of a sequence of the following two messages. A photograph showing a delay message is shown in Figure 4.

ROADWAY		X MIN
ADVISORY		DELAY
XX AM OR PM	followed by	AHEAD

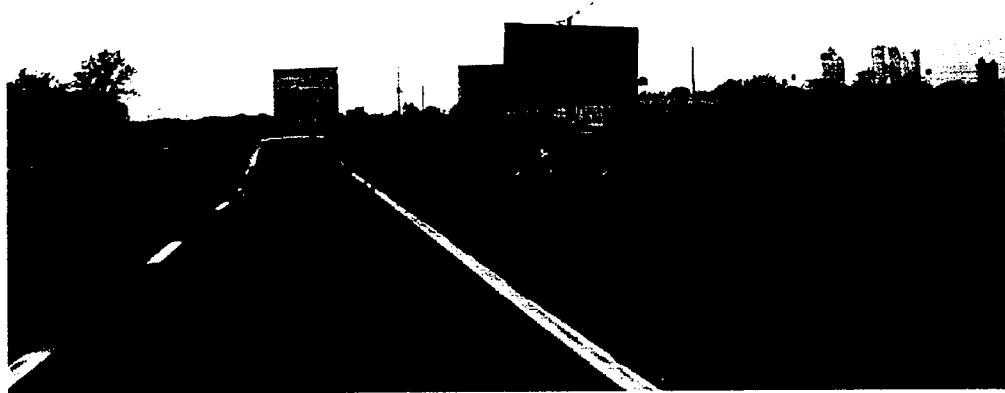
Figure 5. Long Delay Message.

The final message related to an alternate route. It was displayed when the delay reached 15 minutes and this delay was maintained for a minimum time of 10 minutes for the ADAPTIR system and 9 minutes for the contractor's system. The diversion message consisted of a sequence of the following two messages (Figures 5 and 6).

LONG  
DELAYS  
AHEAD

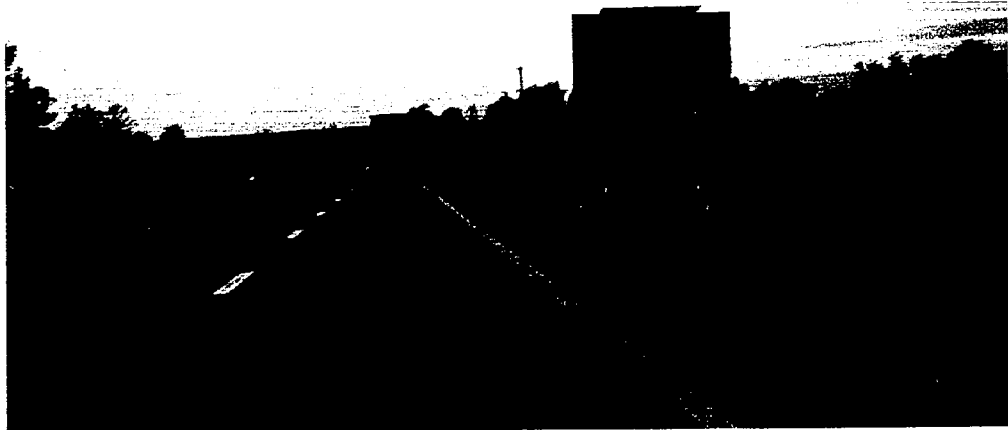
Figure 6. Alternate Route Message.

ALT RTE  
FOLLOW  
EXIT XX

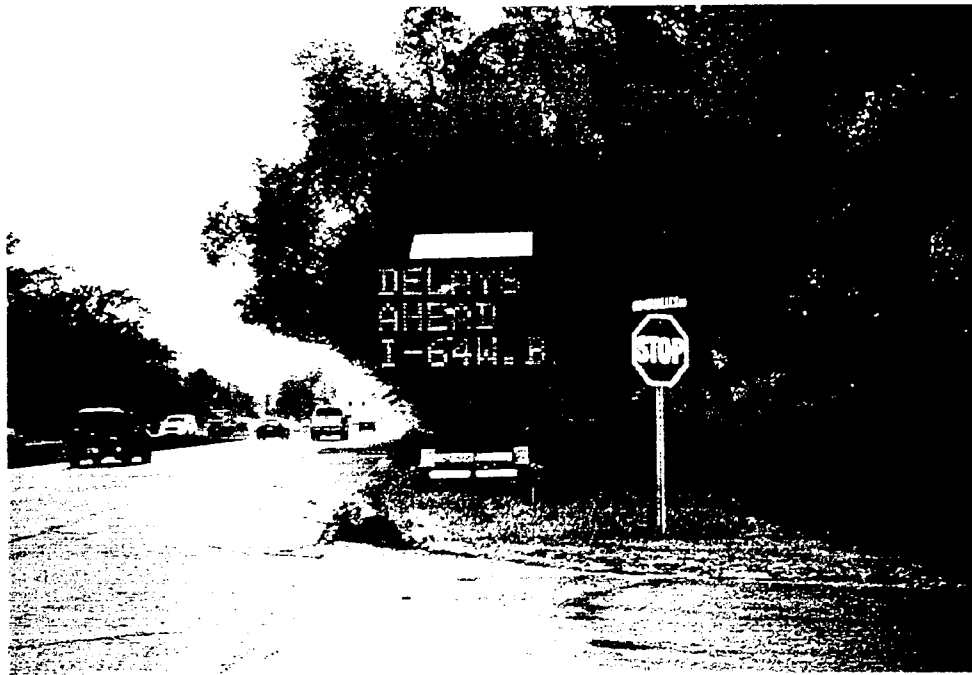
Figure 7. Message on Intersecting Route Advising of Delay on I 64.

This system provided information to motorists on the interstate. Additional VMS were placed on the diversion route to provide information when excessive delays occurred (Figures 7 and 8). The messages on these signs were input manually.

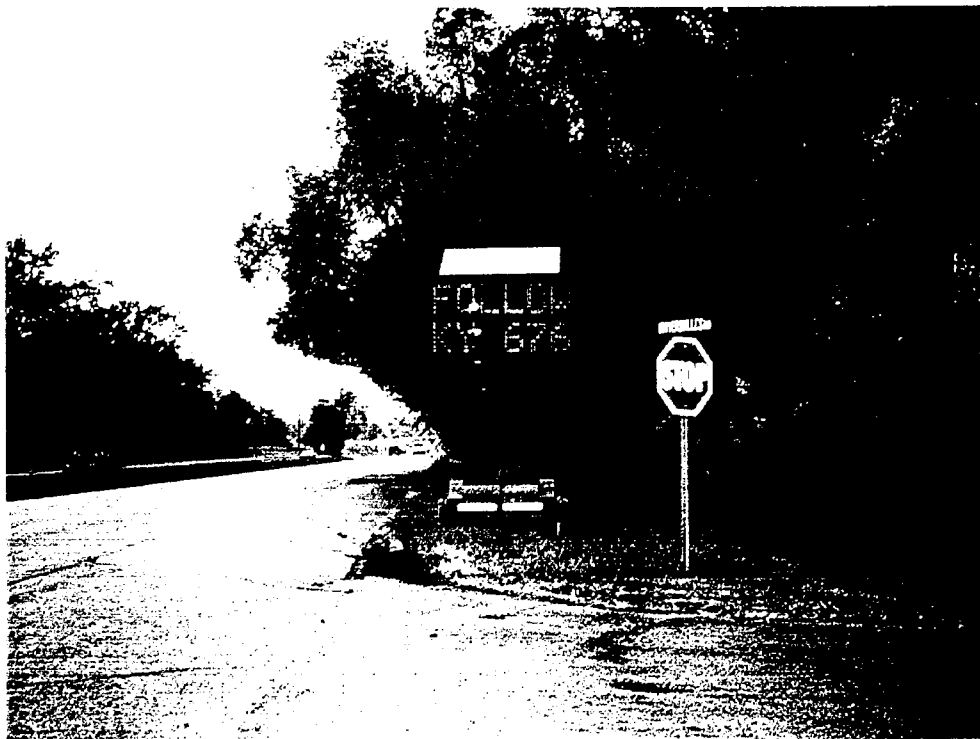
Figure 8. Message on Intersecting Route Advising Use of Alternate Route.
